**Flood Control Project Maintenance
Levee Inspections**
LMA District Cover Sheet
Spring 2019 Levee Inspection Results

Sutter Maintenance Yard East Levee Sutter Bypass

Spring 2019 Levee Inspection Results

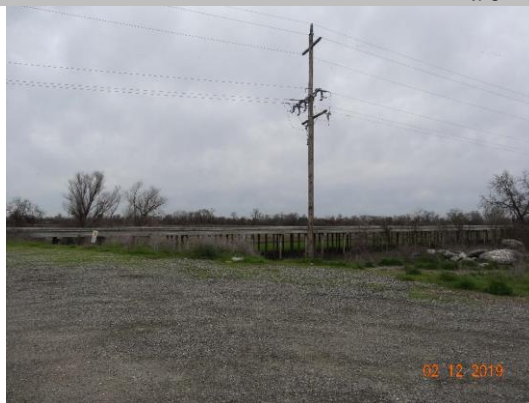
Photo 2 of 3 : UCIP_SP_2019_53669_78812.jpg

WS view: overview of crown.

Comment Code						
Inspector Comment						
FS_ID:53669 DS_ID:16867 EP_NO: 768 Repair Type: Non-Urgent Crossing Status: Indicator Found UCIP Comments: 02/12/2019 Need to request maintenance and inspection records to confirm condition of line through levee. Gas line marker previously located on the WS slope has been damaged, recommend replacing. Structure description has been updated based on the permit review of 14802 (dsid 16867) and 768 (dsid 25575). USACE PI issue references Permit No. 768 for this crossing correct Permit No. should be 14802. (O. Magana - DWR UCIP)4/11/2017 Crossing appears to be in good condition. (DWR Sutter Yard-AFreitag)10/10/2016 Crossing appears to be in good condition.(DWR Sutter Yard - afreitag)4/18/2016 Crossing appears in good condition. No noticeable issues to report.5/7/2015 Crossing is in good condition. No noticeable issues to report.11/12/2014 Same as last inspection.5/13/2014 Same as last inspection.10/30/2103 Same as last inspection.5/22/2013 Same as last inspection. FIELD_STRUCT_DESC: 4-inch steel gas line through the levee, 30-inches below the crown. Carsonite marker located on the waterside (WS) shoulder and on road, 200 feet east of levee crossing (4-inch line authorized under Permit No. 14802, 1987 - Pacific Gas and Electric Company [PG&E]; 4-inch line replaces previous 3.5-inch line authorized under Permit No. 768, 1939 - PG&E). FS Date: 2/12/2019 3:01:00 PM

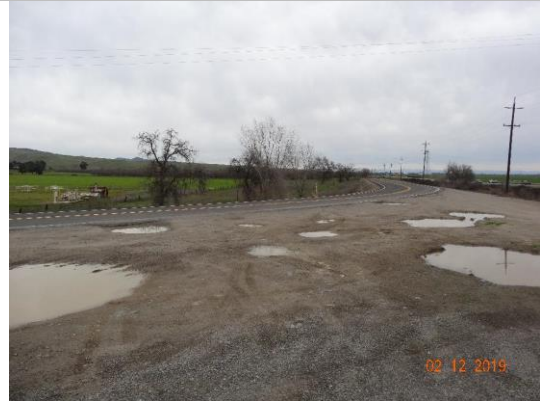
Photo 3 of 3 : UCIP_SP_2019_53669_78807.jpg

Overview of line through W Butte Road and shoulder (levee section).

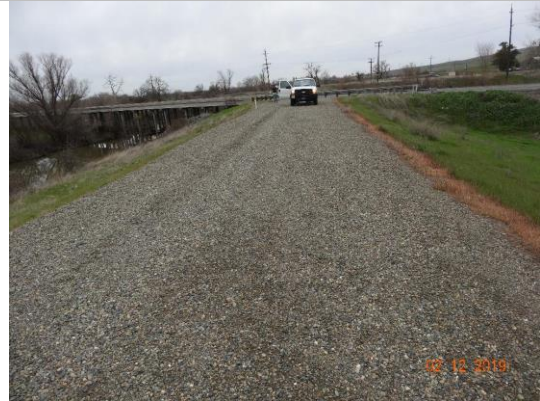
Photo 1 of 3 : UCIP_SP_2019_53738_78815.jpg

FS_ID:53738
DS_ID:16890
EP_NO: 13363
Repair Type: Non-Urgent
Crossing Status: Not Found
UCIP Comments: 02/12/2019 Modifications to the encroachment have been made since 2012. Unable to confirm if the line previously recorded in 2012 was removed or if a completely new line was added about 10-feet south of current location. Underground service alert (USA) flag recorded in 2012 shows AT&T line, permit indicates PT&T, and 2019 control box shows CVIC. Need to update permit with current owner. Need contact owner to clarify conduit alignment and modifications completed after 2012. (O. Magana - DWR UCIP)4/11/2017 Crossing appears to be in good condition. (DWR Sutter Yard-AFreitag)10/10/2016 Crossing appears to be in good condition.(DWR Sutter Yard - aFreitag)4/18/2016 Crossing appears in good condition. No noticeable issues to report.5/7/2015 Crossing is in good condition. No noticeable issues to report.11/12/2014 Same as last inspection.5/13/2014 Same as last inspection.10/30/2103 Same as last inspection.5/22/2013 Same as last inspection.

Overview of levee crown at line crossing, photo 1 of 2.

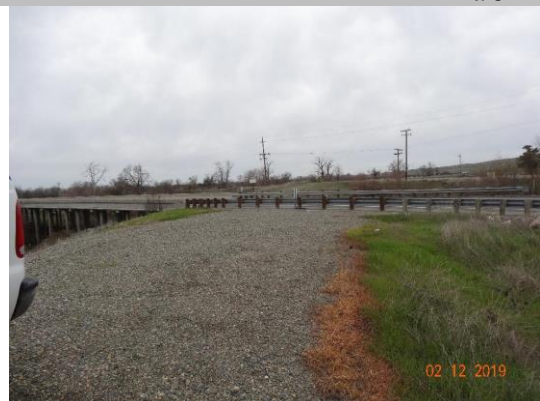
Photo 2 of 3 : UCIP_SP_2019_53738_78822.jpg

Overview of levee crown at line crossing, photo 2 of 2

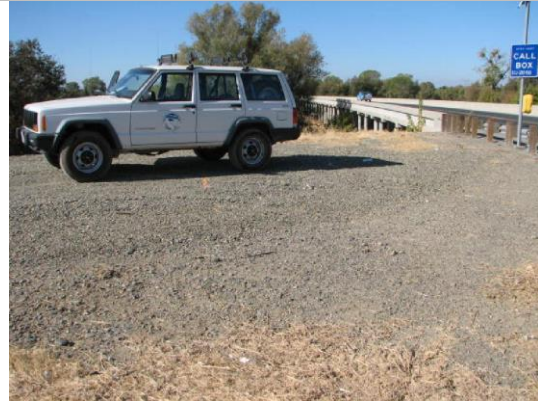
Photo 3 of 3 : UCIP_SP_2019_53738_64778.jpg

Comment Code						
Inspector Comment						
FS_ID:53738 DS_ID:16890 EP_NO: 13363 Repair Type: Non-Urgent Crossing Status: Not Found UCIP Comments: 02/12/2019 Modifications to the encroachment have been made since 2012. Unable to confirm if the line previously recorded in 2012 was removed or if a completely new line was added about 10-feet south of current location. Underground service alert (USA) flag recorded in 2012 shows AT&T line, permit indicates PT&T, and 2019 control box shows CVIC. Need to update permit with current owner. Need contact owner to clarify conduit alignment and modifications completed after 2012. (O. Magana - DWR UCIP)4/11/2017 Crossing appears to be in good condition. (DWR Sutter Yard-AFreitag)10/10/2016 Crossing appears to be in good condition.(DWR Sutter Yard - afreitag)4/18/2016 Crossing appears in good condition. No noticeable issues to report.5/7/2015 Crossing is in good condition. No noticeable issues to report.11/12/2014 Same as last inspection.5/13/2014 Same as last inspection.10/30/2103 Same as last inspection.5/22/2013 Same as last inspection. FIELD_STRUCT_DESC: 4-inch steel communications conduit through the levee, 4 feet below the crown. Design drawings available in permit. (4-inch line authorized under Permit No. 16850, 1998 - Pacific Bell; previous 4-inch line removed under Permit No. 13363 and 16647 in 1998). FS Date: 2/12/2019 3:01:00 PM

Alignment painted on gravel at door of jeep.

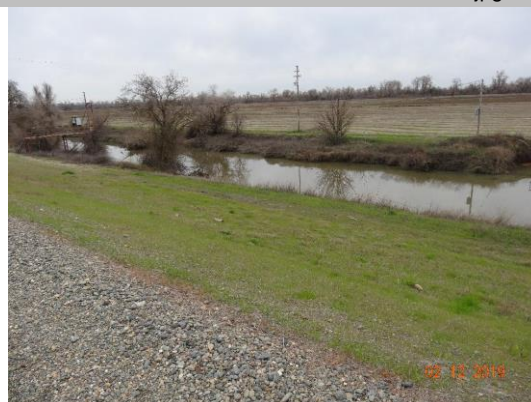
Photo 2 of 3 : UCIP_SP_2019_53671_78826.jpg

Comment Code						
Inspector Comment						
FS_ID:53671 DS_ID:16860 EP_NO: 4795 Repair Type: Non-Urgent Crossing Status: Indicator Found UCIP Comments: 02/12/2019 (O. Magana - DWR UCIP)01/10/2019 Permit records indicate marker signs were to be placed over the gasline in the bypass channel and in the levee section - confirm in the field. (O. Magana - DWR UCIP) 4/11/2017 Crossing appears to be in good condition. (DWR Sutter Yard- AFreitag)10/10/2016 Crosing appears to be in good condition.(DWR Sutter Yard - afreitag)4/18/2016 Crossing appears in good condition. No noticeable issues to report.5/7/2015 Crossing is in good condition. No noticeable issues to report.11/12/2014 Same as last inspection.5/13/2014 Same as last inspection.5/22/2013 Same as last inspection.10/30/2103 Same as last inspection. FIELD_STRUCT_DESC: 10-inch steel gas line through the levee, 4 feet below the crown. Pipe is 0.375 inches thick and soil proofed. Pressure gas line goes through the left bank, under the channel of Sutter Bypass, and right bank. (10-inch line authorized under Permit No. 4795, 1965 - Pacific Gas and Electric Company [PG&E]). [Additional Reference(s): DWR Levee Log, 2005]. FS Date: 2/12/2019 3:02:00 PM

WS view: overview of WS. No visible marker found on WS.

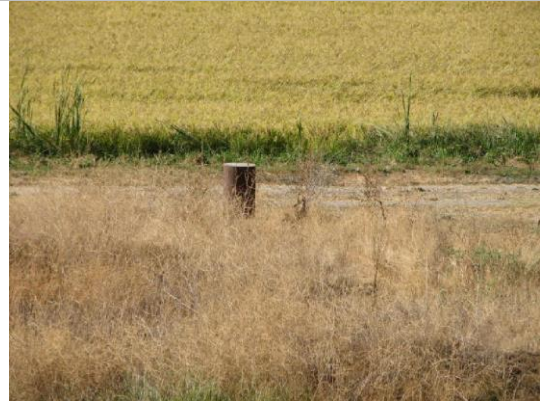
Photo 3 of 3 : UCIP_SP_2019_53671_65220.jpg

Comment Code						
Inspector Comment						
FS_ID:53671 DS_ID:16860 EP_NO: 4795 Repair Type: Non-Urgent Crossing Status: Indicator Found UCIP Comments: 02/12/2019 (O. Magana - DWR UCIP)01/10/2019 Permit records indicate marker signs were to be placed over the gasoline in the bypass channel and in the levee section - confirm in the field. (O. Magana - DWR UCIP) 4/11/2017 Crossing appears to be in good condition. (DWR Sutter Yard- AFreitag)10/10/2016 Crosing appears to be in good condition.(DWR Sutter Yard - afreitag)4/18/2016 Crossing appears in good condition. No noticeable issues to report.5/7/2015 Crossing is in good condition. No noticeable issues to report.11/12/2014 Same as last inspection.5/13/2014 Same as last inspection.5/22/2013 Same as last inspection.10/30/2103 Same as last inspection. FIELD_STRUCT_DESC: 10-inch steel gas line through the levee, 4 feet below the crown. Pipe is 0.375 inches thick and soil proofed. Pressure gas line goes through the left bank, under the channel of Sutter Bypass, and right bank. (10-inch line authorized under Permit No. 4795, 1965 - Pacific Gas and Electric Company [PG&E]). [Additional Reference(s): DWR Levee Log, 2005]. FS Date: 2/12/2019 3:02:00 PM

Possible vent on WS accross channel.

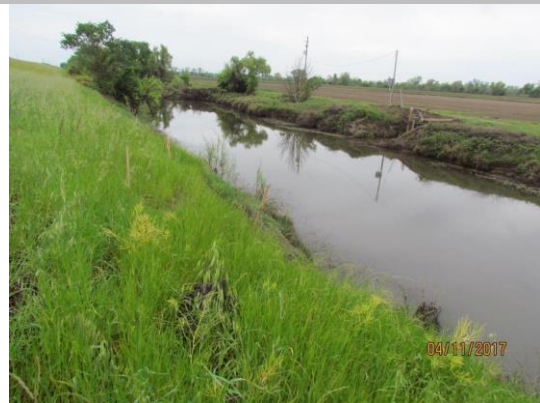
Photo 1 of 1 : SP_2019_ST0002_450_42_20190327_00009.jpg

LM Start	0.36	Rating **	M	Issue No.	42
LM End	0.36	Issue Type +	Ma	Location *	WS
Category	Earthen Levee			GPS Latitude/Longitude	
				Start	End
Item	Erosion / Bank Caving			39.147183 °	39.147183 °
				-121.828142 °	-121.828142 °
DWR ID	DWR_ST0002_01_s_ 2017_42				
Comment Code					
E2 : Schedule repair of erosion site prior to the next inspection.					
Inspector Comment					
Repair the erosion along the waterside toe.

View of the erosion along the waterside toe.

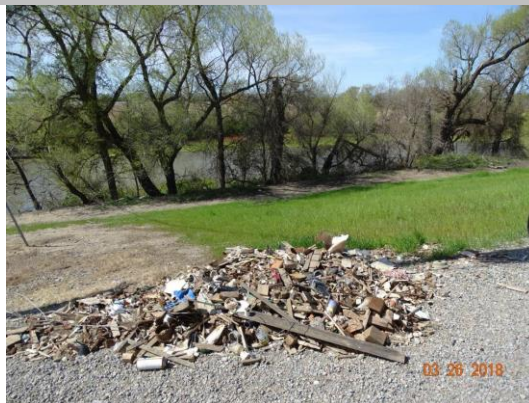
Photo 1 of 1 : SP_2019_ST0002_450_46_20190327_00012.jpg

View of the garbage along the waterside slope.

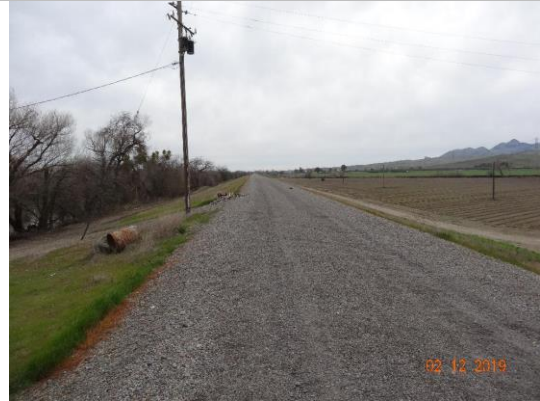
Photo 1 of 3 : UCIP_SP_2019_53674_78843.jpg

Comment Code					
Inspector Comment					
FS_ID:53674 DS_ID:16862 EP_NO: 10932 Repair Type: Non-Urgent Crossing Status: Found UCIP Comments: 02/12/2019 (O. Magana - DWR UCIP)4/11/2017 Riser knocked out of place on WS shoulder and no sign of the siphon breaker. Suspect it was buried. (DWR Sutter Yard- AFreitag)10/10/2016 WS CMP riser is still knocked out of place and siphon breaker is suspected to be buried.(DWR Sutter Yard - afreitag)4/18/2016 CMP riser is still knocked out of place and a siphon breaker cannot be found.5/7/2015 24in. cmp riser and siphon breaker were not found on the WS shoulder.11/12/2014 Same as last inspection.5/13/2014 Same as last inspection.10/30/2013 24in. cmp riser was pulled out of levee and there is no sign of a siphon breaker on WS shoulder.5/22/2013 24in. cmp riser on WS shoulder is full of garbage and dirt and should be cleaned out to inspect siphon breaker.10/8/2012 Pier has no walkway to access pump on pier. This is not necessarily an issue. FIELD_STRUCT_DESC: 16-inch coated steel irrigation pipe through the levee, 6.3 feet below the crown. Vertical pump mounted on a steel structure on the bank. Siphon breaker in a 24-inch corrugated metal pipe riser on the waterside (WS) slope. Concrete distribution box on the landside (LS). Power and communication joint pole (JP) on the WS shoulder. Original equipment in O&M. Hand drawings available in permit. (Original 16-inch O&M pipe removed in 1975 and replaced with a 16-inch pipe under Permit No. 10932, 1976 - Edward Nall) [Additional Reference(s): DWR Levee Log, 2005. USACE Sacramento O&M Manual 315, May 1953 (Station 1094+80)]. FS Date: 2/12/2019 3:03:00 PM

Overview of levee crown, photo taken d/s looking u/s towards crossing.

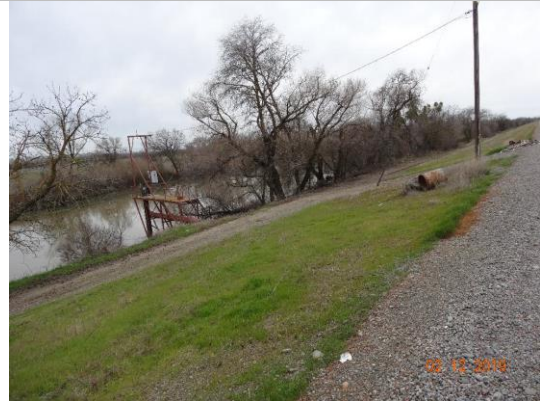
Photo 2 of 3 : UCIP_SP_2019_53674_78842.jpg

Comment Code						
Inspector Comment						
FS_ID:53674 DS_ID:16862 EP_NO: 10932 Repair Type: Non-Urgent Crossing Status: Found UCIP Comments: 02/12/2019 (O. Magana - DWR UCIP)4/11/2017 Riser knocked out of place on WS shoulder and no sign of the siphon breaker. Suspect it was buried. (DWR Sutter Yard- AFreitag)10/10/2016 WS CMP riser is still knocked out of place and siphon breaker is suspected to be buried.(DWR Sutter Yard - afreitag)4/18/2016 CMP riser is still knocked out of place and a siphon breaker cannot be found.5/7/2015 24in. cmp riser and siphon breaker were not found on the WS shoulder.11/12/2014 Same as last inspection.5/13/2014 Same as last inspection.10/30/2013 24in. cmp riser was pulled out of levee and there is no sign of a siphon breaker on WS shoulder.5/22/2013 24in. cmp riser on WS shoulder is full of garbage and dirt and should be cleaned out to inspect siphon breaker.10/8/2012 Pier has no walkway to access pump on pier. This is not necessarily an issue. FIELD_STRUCT_DESC: 16-inch coated steel irrigation pipe through the levee, 6.3 feet below the crown. Vertical pump mounted on a steel structure on the bank. Siphon breaker in a 24-inch corrugated metal pipe riser on the waterside (WS) slope. Concrete distribution box on the landside (LS). Power and communication joint pole (JP) on the WS shoulder. Original equipment in O&M. Hand drawings available in permit. (Original 16-inch O&M pipe removed in 1975 and replaced with a 16-inch pipe under Permit No. 10932, 1976 - Edward Nall) [Additional Reference(s): DWR Levee Log, 2005. USACE Sacramento O&M Manual 315, May 1953 (Station 1094+80)]. FS Date: 2/12/2019 3:03:00 PM

WS view: overview of WS, photo taken d/s looking u/s towards crossing.

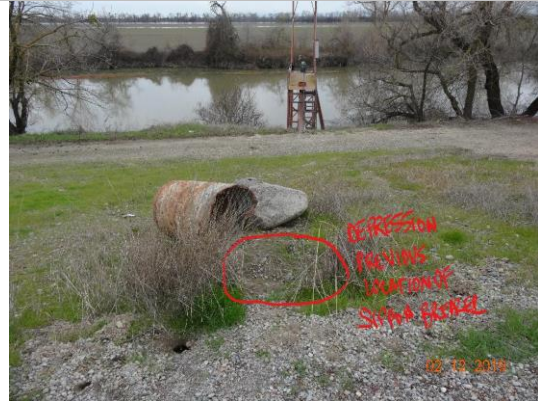
Photo 3 of 3 : UCIP_SP_2019_53674_78845.jpg

Comment Code						
Inspector Comment						
FS_ID:53674 DS_ID:16862 EP_NO: 10932 Repair Type: Non-Urgent Crossing Status: Found UCIP Comments: 02/12/2019 (O. Magana - DWR UCIP)4/11/2017 Riser knocked out of place on WS shoulder and no sign of the siphon breaker. Suspect it was buried. (DWR Sutter Yard- AFreitag)10/10/2016 WS CMP riser is still knocked out of place and siphon breaker is suspected to be buried.(DWR Sutter Yard - afreitag)4/18/2016 CMP riser is still knocked out of place and a siphon breaker cannot be found.5/7/2015 24in. cmp riser and siphon breaker were not found on the WS shoulder.11/12/2014 Same as last inspection.5/13/2014 Same as last inspection.10/30/2013 24in. cmp riser was pulled out of levee and there is no sign of a siphon breaker on WS shoulder.5/22/2013 24in. cmp riser on WS shoulder is full of garbage and dirt and should be cleaned out to inspect siphon breaker.10/8/2012 Pier has no walkway to access pump on pier. This is not necessarily an issue. FIELD_STRUCT_DESC: 16-inch coated steel irrigation pipe through the levee, 6.3 feet below the crown. Vertical pump mounted on a steel structure on the bank. Siphon breaker in a 24-inch corrugated metal pipe riser on the waterside (WS) slope. Concrete distribution box on the landside (LS). Power and communication joint pole (JP) on the WS shoulder. Original equipment in O&M. Hand drawings available in permit. (Original 16-inch O&M pipe removed in 1975 and replaced with a 16-inch pipe under Permit No. 10932, 1976 - Edward Nall) [Additional Reference(s): DWR Levee Log, 2005. USACE Sacramento O&M Manual 315, May 1953 (Station 1094+80)]. FS Date: 2/12/2019 3:03:00 PM

WS view: soil disturbance where riser was previously located.

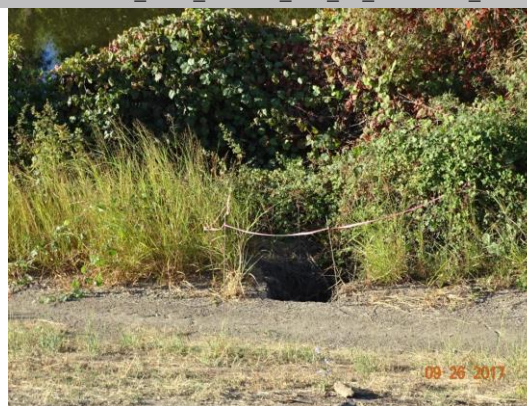
Photo 1 of 1 : SP_2019_ST0002_450_57_20190327_00013.jpg

LM Start	1.53	Rating **	U	Issue No.	57
LM End	1.53	Issue Type +	Ma	Location *	WS
Category	Earthen Levee			GPS Latitude/Longitude	
				Start	End
Item	Erosion / Bank Caving			39.137373 °	39.137373 °
				-121.810382 °	-121.810382 °
DWR ID	DWR_ST0002_01_f_2017_57				
Comment Code					
E2 : Schedule repair of erosion site prior to the next inspection.					
Inspector Comment					
Repair the beaver hole along the waterside berm.

View of the beaver hole along the waterside berm.

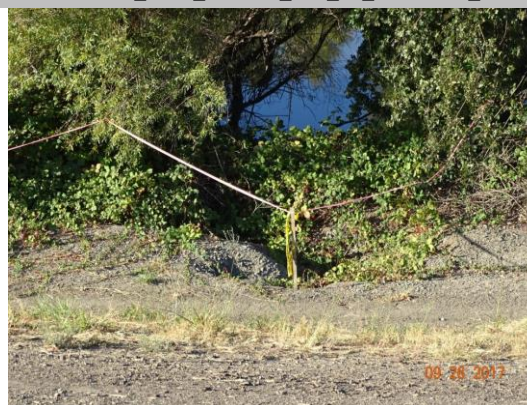
Photo 1 of 1 : SP_2019_ST0002_450_58_20190327_00014.jpg

LM Start	1.57	Rating **	U	Issue No.	58
LM End	1.57	Issue Type +	Ma	Location *	WS
Category	Earthen Levee			GPS Latitude/Longitude	
				Start	End
Item	Erosion / Bank Caving			39.137010 °	39.137010 °
				-121.809673 °	-121.809673 °
DWR ID	DWR_ST0002_01_f_2017_58				
Comment Code					
E2 : Schedule repair of erosion site prior to the next inspection.					
Inspector Comment					
Repair the beaver hole along the waterside berm.

View of the beaver hole along the waterside berm.

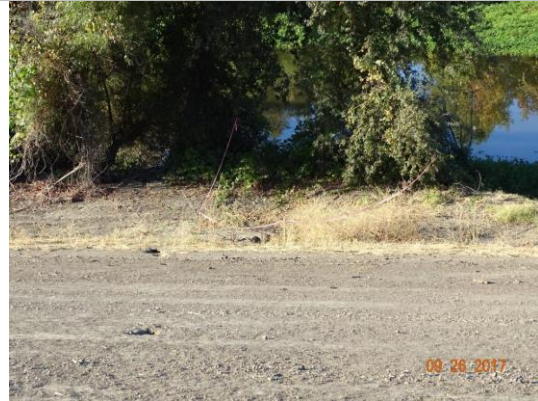
Photo 1 of 1 : SP_2019_ST0002_450_61_20190327_00015.jpg

LM Start	1.61	Rating **	U	Issue No.	61
LM End	1.61	Issue Type +	Ma	Location *	WS
Category	Earthen Levee			GPS Latitude/Longitude	
				Start	End
Item	Erosion / Bank Caving			39.136713 °	39.136713 °
				-121.809202 °	-121.809202 °
DWR ID	DWR_ST0002_01_f_2017_61				
Comment Code					
E2 : Schedule repair of erosion site prior to the next inspection.					
Inspector Comment					
Repair the beaver hole along the waterside berm.

View of the beaver hole along the waterside berm.

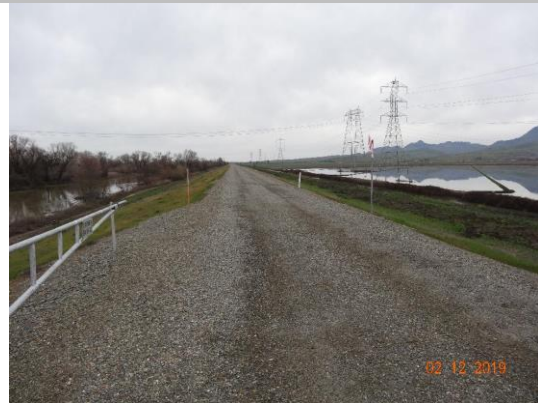
Photo 1 of 3 : UCIP_SP_2019_53675_78848.jpg

Comment Code						
Inspector Comment						
FS_ID:53675 DS_ID:16864 EP_NO: 3890 Repair Type: Non-Urgent Crossing Status: Indicator Found UCIP Comments: 02/12/2019 (O. Magana - DWR UCIP)4/11/2017 Crossing appears to be in good condition. (DWR Sutter Yard-AFreitag)10/10/2016 Crossing appears to be in good condition.(DWR Sutter Yard - afreitag)4/18/2016 Crossing appears in good condition. No noticeable issues to report.5/7/2015 Crossing is in good condition. No noticeable issues to report.11/12/2014 Same as last inspection.5/13/2014 Same as last inspection.10/30/2103 Same as last inspection.5/22/2013 Same as last inspection. FIELD_STRUCT_DESC: 10.75-inch steel gas pipeline through the levee, 2.6 feet below the crown. Gas line markers located on the landside (LS) and the waterside (WS) toes. Gas valve in steel riser unit on the LS toe at edge of canal. Line crosses the channel and goes through both Sutter Bypass levees. Design drawings available. (10.75-inch line authorized under Permit No. 3890, 1962 - Pacific Gas and Electric Company [PG&E]). [Additional Reference(s): DWR Levee Log, 2005]. FS Date: 2/12/2019 3:04:00 PM

Overview of levee crown, photo taken d/s looking u/s towards crossing.

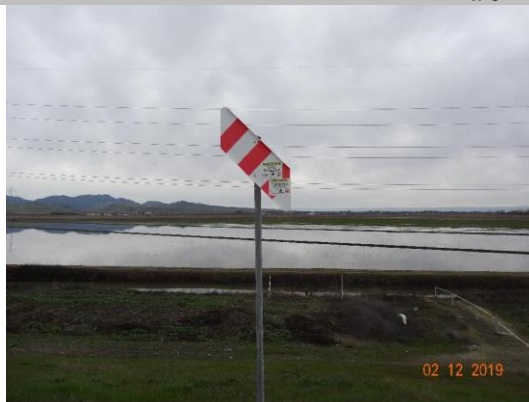
Photo 3 of 3 : UCIP_SP_2019_53675_78849.jpg

FS_ID:53675
DS_ID:16864
EP_NO: 3890
Repair Type: Non-Urgent
Crossing Status: Indicator Found
UCIP Comments: 02/12/2019 (O. Magana - DWR UCIP)4/11/2017 Crossing appears to be in good condition. (DWR Sutter Yard- AFreitag)10/10/2016 Crossing appears to be in good condition.(DWR Sutter Yard - afreitag)4/18/2016 Crossing appears in good condition. No noticeable issues to report.5/7/2015 Crossing is in good condition. No noticeable issues to report.11/12/2014 Same as last inspection.5/13/2014 Same as last inspection.10/30/2103 Same as last inspection.5/22/2013 Same as last inspection.
FIELD_STRUCT_DESC: 10.75-inch steel gas pipeline through the levee, 2.6 feet below the crown. Gas line markers located on the landside (LS) and the waterside (WS) toes. Gas valve in steel riser unit on the LS toe at edge of canal. Line crosses the channel and goes through both Sutter Bypass levees. Design drawings available. (10.75-inch line authorized under Permit No. 3890, 1962 - Pacific Gas and Electric Company [PG&E]). [Additional Reference(s): DWR Levee Log, 2005].

LS view: marker indicating line crosses levee.

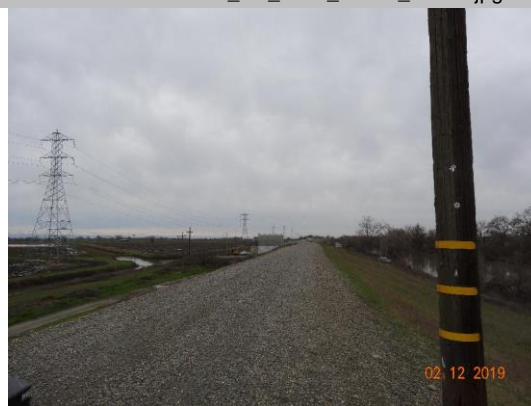
Photo 1 of 3 : UCIP_SP_2019_53682_78856.jpg

Comment Code					
Inspector Comment					
FS_ID:53682 DS_ID:16880 EP_NO: N/A Repair Type: Non-Urgent Crossing Status: Found UCIP Comments: 02/12/2019 (O. Magana - DWR UCIP)01/11/2019 Record has been updated to show pumping plant is still in use and not abandoned. (O. Magana - DWR UCIP) 4/11/2017 Not abandoned. good condition. (DWR Sutter Yard-AFreitag)10/10/2016 NOT ABANDONED. The old pumping plant was removed but the culverts are still used as a gravity drain to regulate the water level in the LS ditch.(DWR Sutter Yard - afreitag)4/18/2016 Crossing is in good condition. The culvert is not abandoned and is used as gravity drain for the LS ditch into the bypass channel.5/7/2015 Concrete culverts are still being used as gravity drains for the LS ditch.11/12/2014 Same as last inspection.5/13/2014 Same as last inspection.10/30/2103 Same as last inspection.5/22/2013 Concrete culvert is being used as gravity drain for LS ditch.10/8/2012 Flap gates left in open position. Unable to determine type of abandonment for concrete culverts. Contact inspector to determine type of abandonment. FIELD_STRUCT_DESC: [Pumping Plant No. 3] 1 of 2: 48-inch by 72-inch reinforced concrete drainage culvert through the levee, 30 feet below the crown. Slide gate in concrete well on the landside (LS) shoulder. Wood flap gate and concrete headwall on the waterside (WS) end. Abandoned State pumping plant on the LS. [Additional Reference(s): DWR Levee Log, 2005. USACE Sacramento O&M Manual 315, May 1953 (Station 966+30)]. FS Date: 2/12/2019 3:05:00 PM

Overview of levee crown looking towards pumping station.

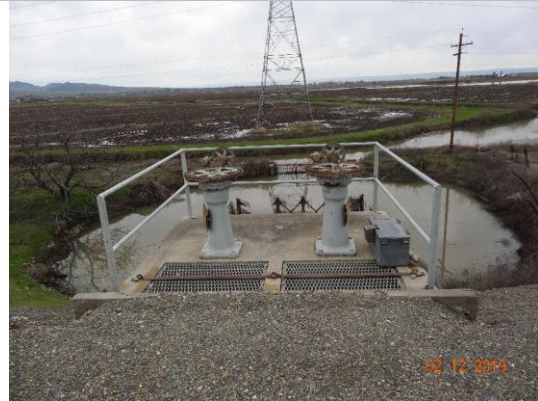
Photo 2 of 3 : UCIP_SP_2019_53682_78857.jpg

Comment Code						
Inspector Comment						
FS_ID:53682 DS_ID:16880 EP_NO: N/A Repair Type: Non-Urgent Crossing Status: Found UCIP Comments: 02/12/2019 (O. Magana - DWR UCIP)01/11/2019 Record has been updated to show pumping plant is still in use and not abandoned. (O. Magana - DWR UCIP) 4/11/2017 Not abandoned. good condition. (DWR Sutter Yard-AFreitag)10/10/2016 NOT ABANDONED. The old pumping plant was removed but the culverts are still used as a gravity drain to regulate the water level in the LS ditch.(DWR Sutter Yard - aFreitag)4/18/2016 Crossing is in good condition. The culvert is not abandoned and is used as gravity drain for the LS ditch into the bypass channel.5/7/2015 Concrete culverts are still being used as gravity drains for the LS ditch.11/12/2014 Same as last inspection.5/13/2014 Same as last inspection.10/30/2103 Same as last inspection.5/22/2013 Concrete culvert is being used as gravity drain for LS ditch.10/8/2012 Flap gates left in open position. Unable to determine type of abandonment for concrete culverts. Contact inspector to determine type of abandonment. FIELD_STRUCT_DESC: [Pumping Plant No. 3] 1 of 2: 48-inch by 72-inch reinforced concrete drainage culvert through the levee, 30 feet below the crown. Slide gate in concrete well on the landside (LS) shoulder. Wood flap gate and concrete headwall on the waterside (WS) end. Abandoned State pumping plant on the LS. [Additional Reference(s): DWR Levee Log, 2005. USACE Sacramento O&M Manual 315, May 1953 (Station 966+30)]. FS Date: 2/12/2019 3:05:00 PM

LS view: slide gate valves located on LS shoulder.

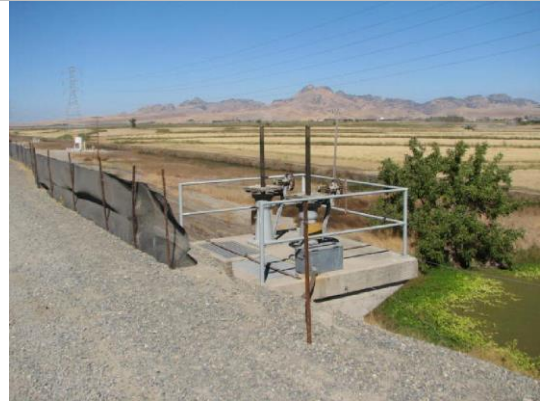
Photo 3 of 3 : UCIP_SP_2019_53682_64815.jpg

Comment Code						
Inspector Comment						
FS_ID:53682 DS_ID:16880 EP_NO: N/A Repair Type: Non-Urgent Crossing Status: Found UCIP Comments: 02/12/2019 (O. Magana - DWR UCIP)01/11/2019 Record has been updated to show pumping plant is still in use and not abandoned. (O. Magana - DWR UCIP) 4/11/2017 Not abandoned. good condition. (DWR Sutter Yard-AFreitag)10/10/2016 NOT ABANDONED. The old pumping plant was removed but the culverts are still used as a gravity drain to regulate the water level in the LS ditch.(DWR Sutter Yard - aFreitag)4/18/2016 Crossing is in good condition. The culvert is not abandoned and is used as gravity drain for the LS ditch into the bypass channel.5/7/2015 Concrete culverts are still being used as gravity drains for the LS ditch.11/12/2014 Same as last inspection.5/13/2014 Same as last inspection.10/30/2103 Same as last inspection.5/22/2013 Concrete culvert is being used as gravity drain for LS ditch.10/8/2012 Flap gates left in open position. Unable to determine type of abandonment for concrete culverts. Contact inspector to determine type of abandonment. FIELD_STRUCT_DESC: [Pumping Plant No. 3] 1 of 2: 48-inch by 72-inch reinforced concrete drainage culvert through the levee, 30 feet below the crown. Slide gate in concrete well on the landside (LS) shoulder. Wood flap gate and concrete headwall on the waterside (WS) end. Abandoned State pumping plant on the LS. [Additional Reference(s): DWR Levee Log, 2005. USACE Sacramento O&M Manual 315, May 1953 (Station 966+30)]. FS Date: 2/12/2019 3:05:00 PM

Slide gates on LS shoulder.

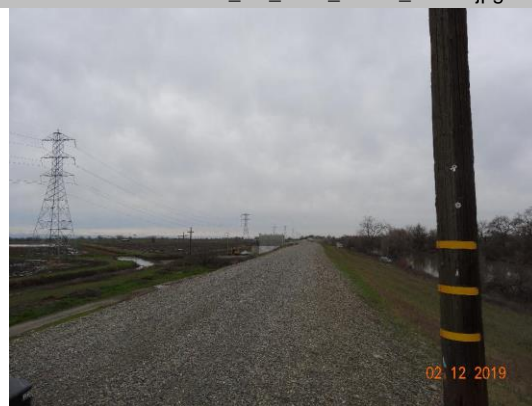
Photo 1 of 3 : UCIP_SP_2019_53681_78863.jpg

Comment Code					
Inspector Comment					
FS_ID:53681 DS_ID:16895 EP_NO: N/A Repair Type: Non-Urgent Crossing Status: Found UCIP Comments: 02/12/2019 (O. Magana - DWR UCIP)01/11/2019 Record has been updated to show pumping plant is still in use and not abandoned. (O. Magana - DWR UCIP) 4/11/2017 Not abandoned. Good condition. (DWR Sutter Yard-AFreitag)10/10/2016 NOT ABANDONED. The old pumping plant was removed but the culverts are still used as a gravity drain to regulate the water level in the LS ditch.(DWR Sutter Yard - afreitag)4/18/2016 Crossing is in good condition. The culvert is not abandoned and is used as gravity drain for the LS ditch into the bypass channel.5/7/2015 Concrete culverst still being used as gravity drains for LS ditch.11/12/2014 Same as last inspection.5/13/2014 Same as last inspection.10/30/2103 Same as last inspection.5/22/2013 Concrete culvert is being used as gravity drain for LS ditch.10/8/2012 Flap gates in open position. Need to determine type of abandonment. Contact inspector to determine abandonment. FIELD_STRUCT_DESC: [Pumping Plant No. 3] 2 of 2: 48-inch by 72-inch reinforced concrete drainage culvert through the levee, 30 feet below the crown. Slide gate in concrete well on the landside (LS) shoulder. Wood flap gate and concrete headwall on the waterside (WS) end. Abandoned State pumping plant on the LS. [Additional Reference(s): DWR Levee Log, 2005. USACE Sacramento O&M Manual 315, May 1953 (Station 966+30)]. FS Date: 2/12/2019 3:06:00 PM

Overview of levee crown looking towards pumping station.

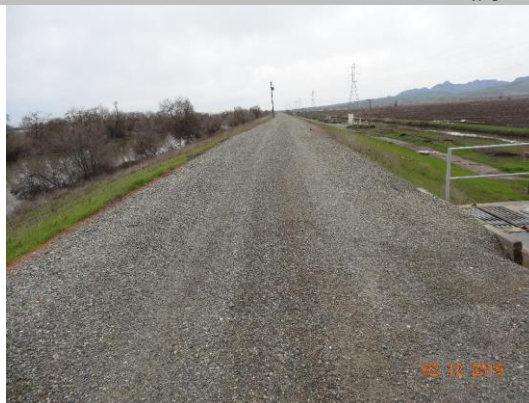
Photo 2 of 3 : UCIP_SP_2019_53681_78866.jpg

Overview of levee crown, photo taken at crossings looking u/s.

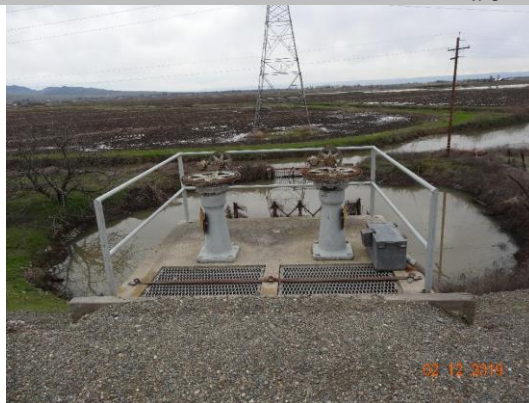
Photo 3 of 3 : UCIP_SP_2019_53681_78864.jpg

LS view: slide gate valves located on LS shoulder.

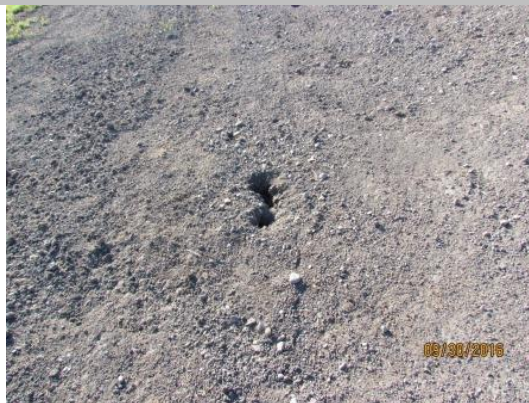
Photo 1 of 1 : SP_2019_ST0002_450_26_20190327_00005.jpg

View of the longitudinal cracks.

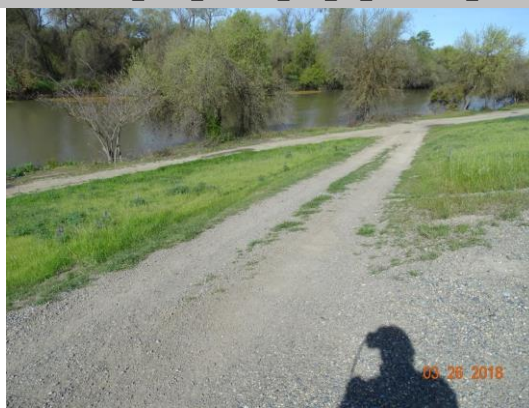
Photo 1 of 1 : SP_2019_ST0002_450_45_20190327_00011.jpg

View of the vehicle traffic along the waterside slope.

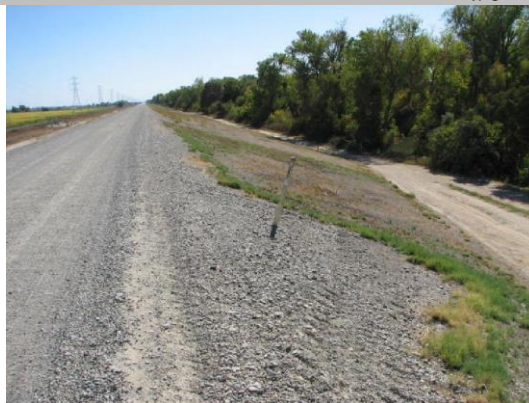
Photo 1 of 3 : UCIP_SP_2019_53888_65213.jpg

Gasline marker on WS shoulder.

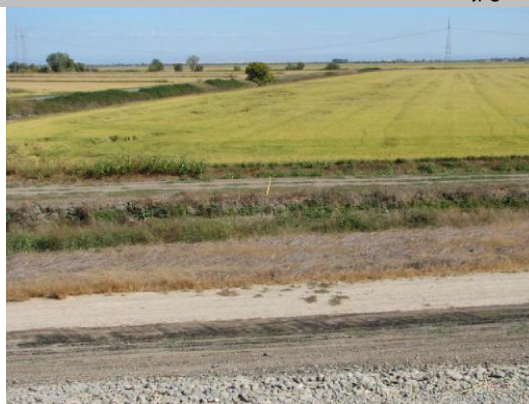
Photo 2 of 3 : UCIP_SP_2019_53888_65212.jpg

Gasline marker on LS toe east of ditch.

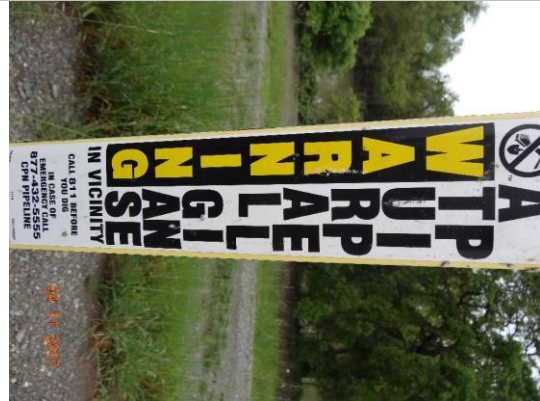
Photo 3 of 3 : UCIP_SP_2019_53888_76970.jpg

Close up of marker

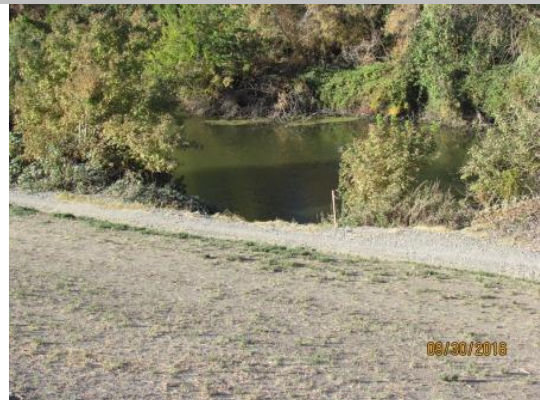
Photo 1 of 1 : SP_2019_ST0002_450_34_20190327_00007.jpg

View of the erosion along the waterside toe.

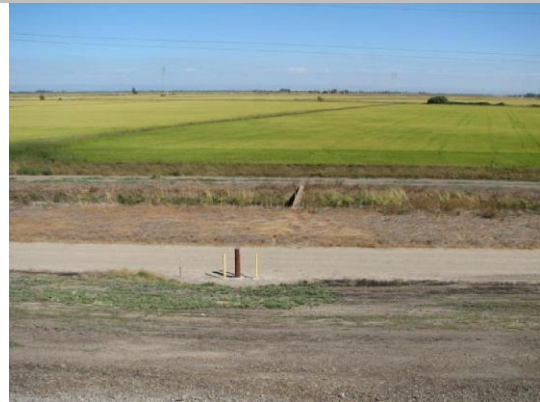
Photo 1 of 2 : UCIP_SP_2019_53889_65215.jpg

Pipe at steel i-beam crossing in ditch at LS toe.

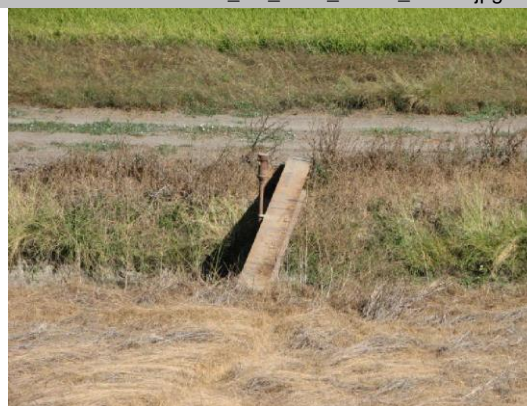
Photo 2 of 2 : UCIP_SP_2019_53889_65214.jpg

Pipe at steel i-beam crossing in ditch at LS toe.

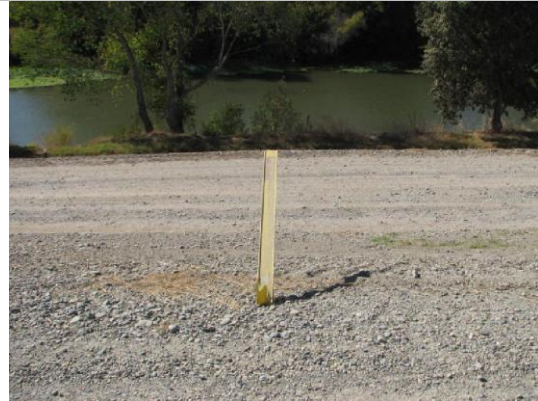
Photo 2 of 3 : UCIP_SP_2019_53875_65216.jpg

Gasline markers on WS shoulder.

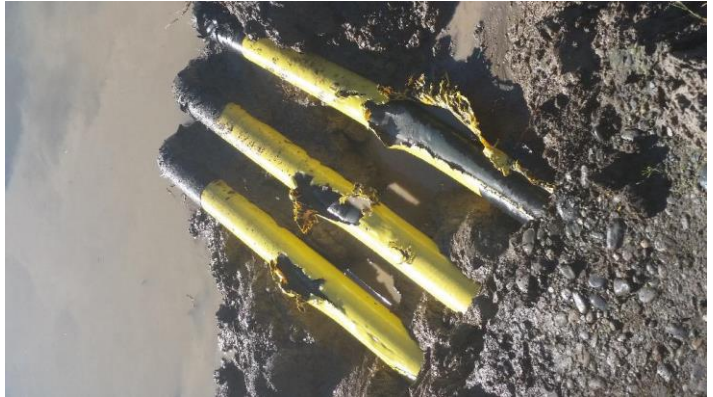
Photo 3 of 3 : UCIP_SP_2019_53875_74958.jpg

Damaged gas lines at the WS berm.

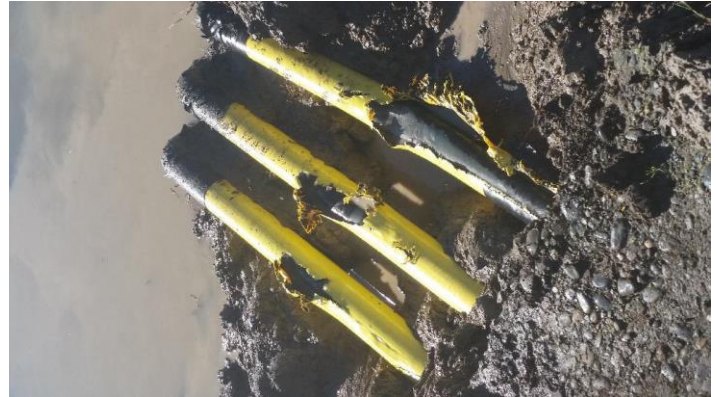
Photo 3 of 3 : UCIP_SP_2019_53876_74959.jpg

Damaged gas lines at the WS berm.

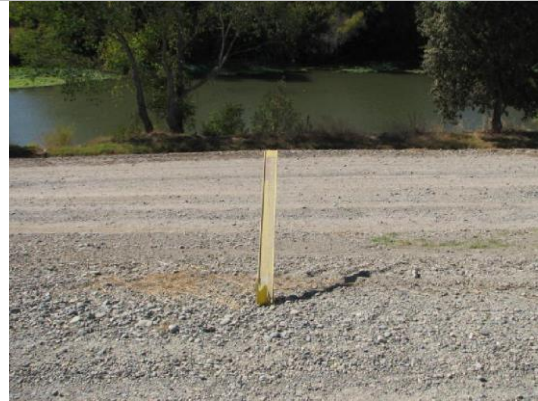
Photo 2 of 3 : UCIP_SP_2019_53877_65223.jpg

Gasline markers on WS shoulder.

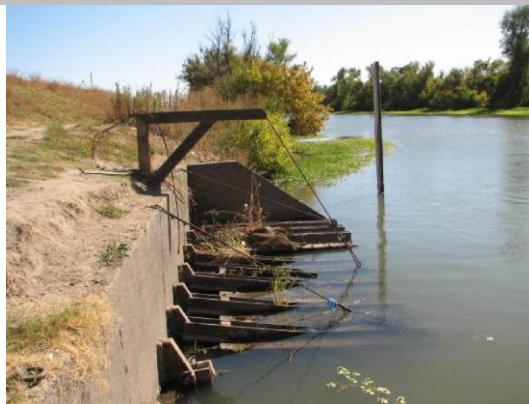
Photo 2 of 3 : UCIP_SP_2019_53897_65250.jpg

Flap gates on WS toe.

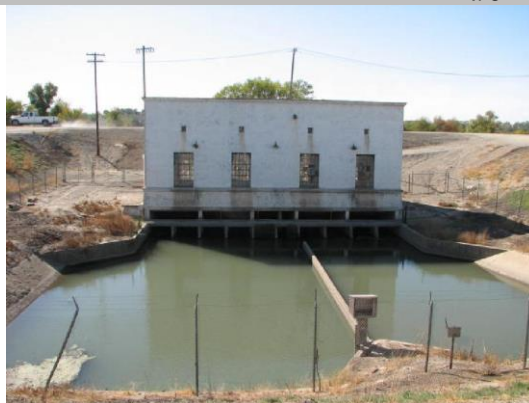
Photo 3 of 3 : UCIP_SP_2019_53897_65249.jpg

Pumphouse/intake structure on LS toe.

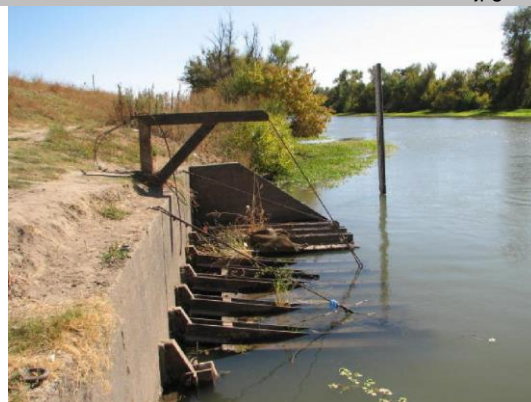
Photo 2 of 3 : UCIP_SP_2019_53898_65253.jpg

Flap gates on WS toe.

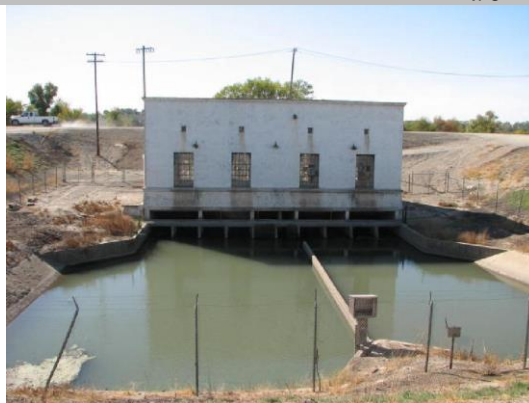
Photo 3 of 3 : UCIP_SP_2019_53898_65252.jpg

Pumping plant on LS toe.

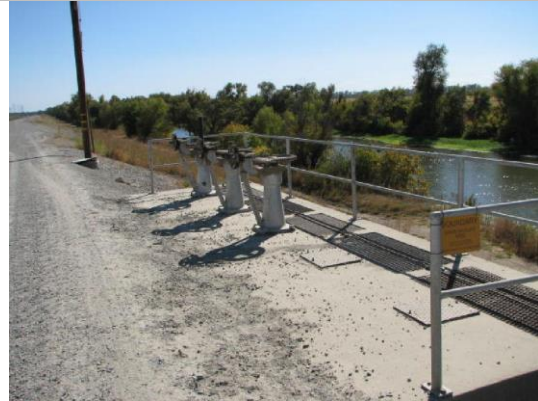
Photo 1 of 3 : UCIP_SP_2019_53899_65257.jpg

Slide gates on WS shoulder.

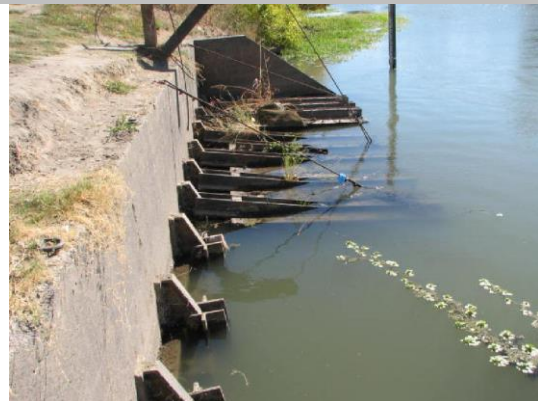
Photo 2 of 3 : UCIP_SP_2019_53899_65256.jpg

Flap gates on WS toe.

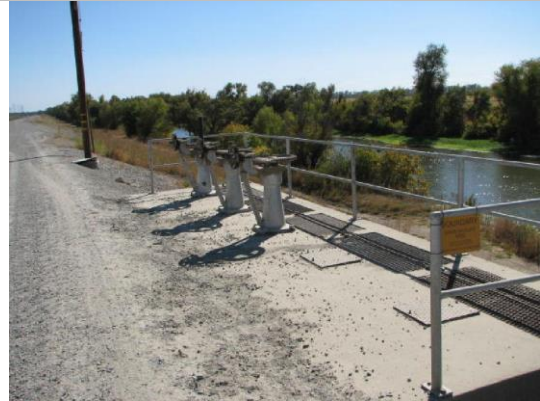
Photo 1 of 3 : UCIP_SP_2019_53930_65260.jpg

Slide gates on WS shoulder.

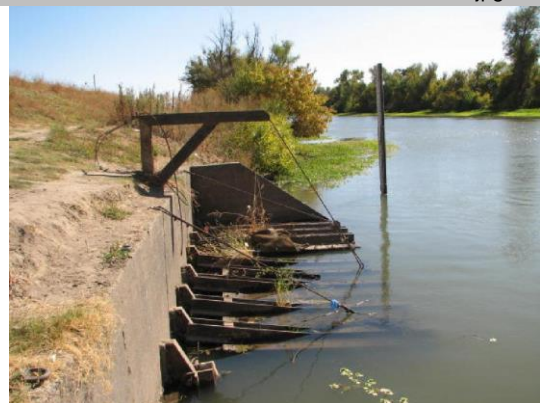
Photo 2 of 3 : UCIP_SP_2019_53930_65259.jpg

Flap gates on WS toe.

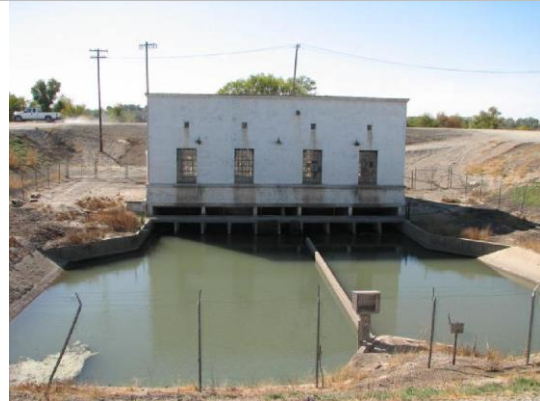
Photo 3 of 3 : UCIP_SP_2019_53930_65258.jpg

Pumphouse and intake on LS toe.

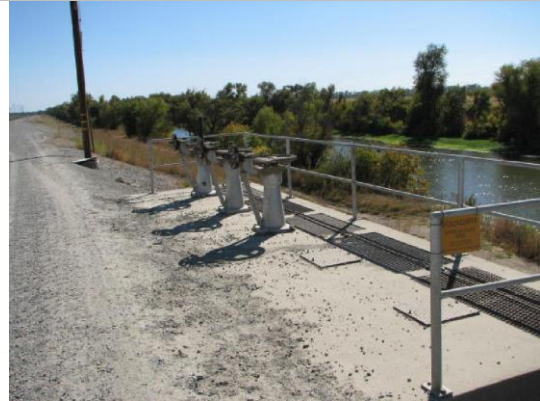
Photo 1 of 3 : UCIP_SP_2019_53931_65263.jpg

Slide gates on WS shoulder.

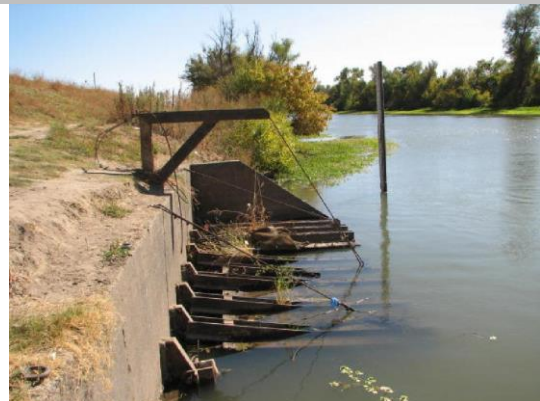
Photo 2 of 3 : UCIP_SP_2019_53931_65262.jpg

Flap gates on WS Toe.

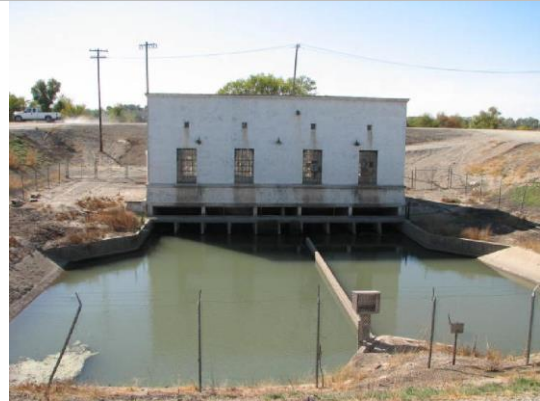
Photo 3 of 3 : UCIP_SP_2019_53931_65261.jpg

Pumphouse/intake on LS toe.

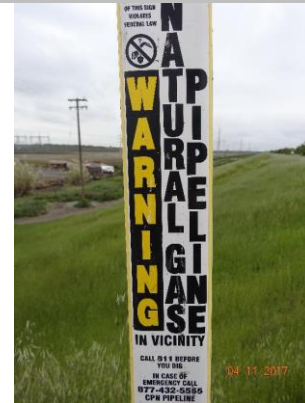
Photo 3 of 3 : UCIP_SP_2019_53933_76971.jpg

Close up of marker

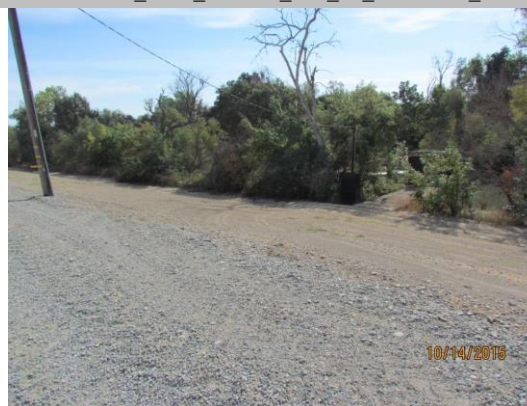
Photo 1 of 1 : SP_2019_ST0002_450_23_20190327_00004.jpg

View of the vehicle erosion along the slope.

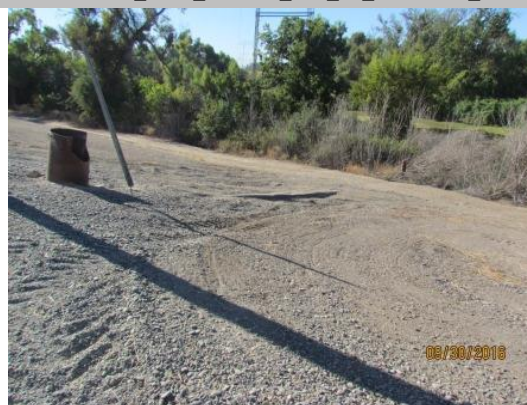
Photo 1 of 1 : SP_2019_ST0002_450_37_20190327_00008.jpg

View of the erosion caused by vehicle traffic.

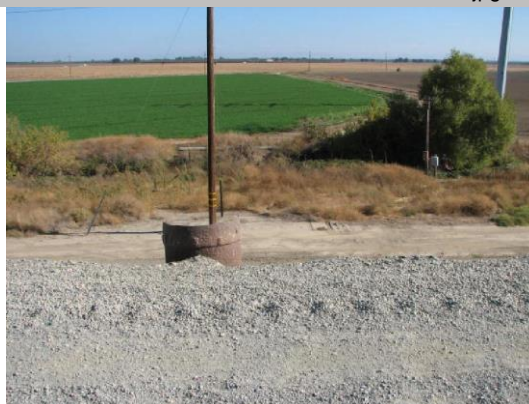
Photo 2 of 3 : UCIP_SP_2019_53937_65313.jpg

Steel riser on LS shoulder.

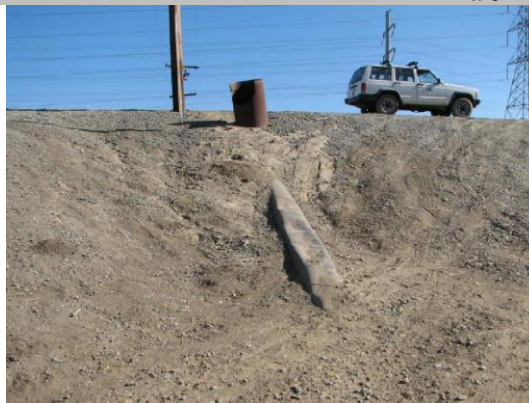
Photo 3 of 3 : UCIP_SP_2019_53937_65312.jpg

Crushed pipe on WS slope.

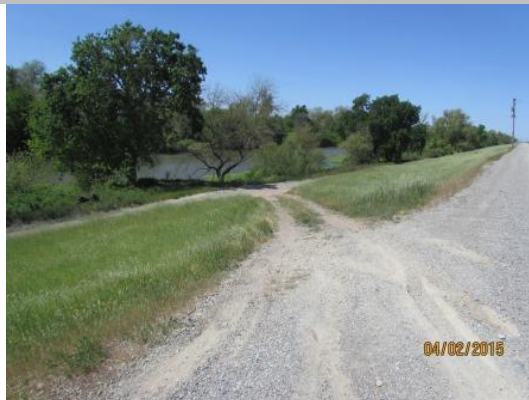
Photo 1 of 2 : SP_2019_ST0002_450_21_20190327_00002.jpg

View of the vehicle erosion along the waterside slope.

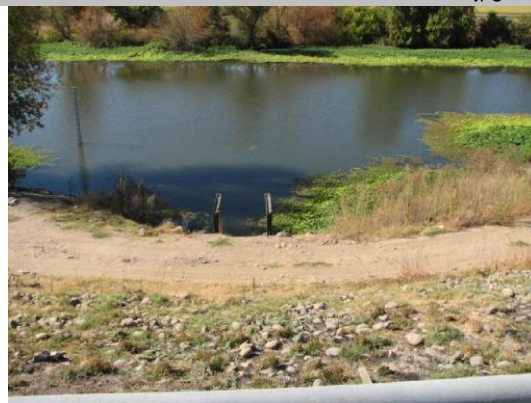
Photo 3 of 3 : UCIP_SP_2019_53911_65327.jpg

Flap gates on WS toe.

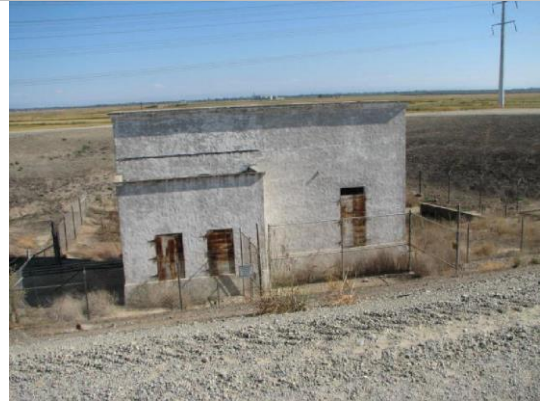
Photo 1 of 3 : UCIP_SP_2019_53912_65330.jpg

Pumphouse on LS toe.

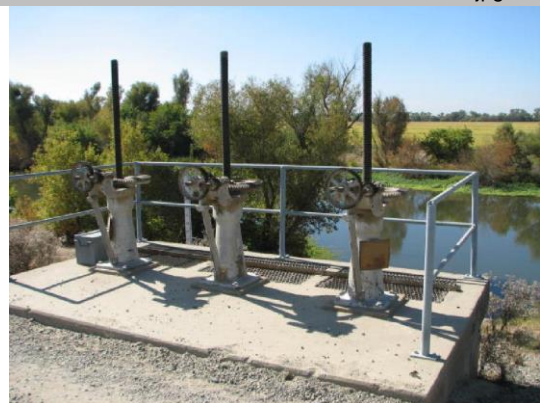
Photo 2 of 3 : UCIP_SP_2019_53912_65329.jpg

Slide gates on WS shoulder.

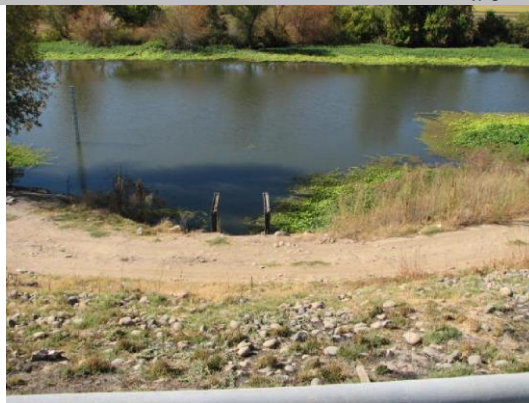
Photo 3 of 3 : UCIP_SP_2019_53912_65328.jpg

Flap gates on WS toe.

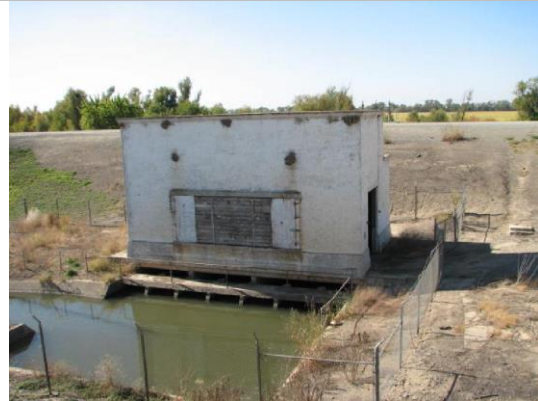
Photo 1 of 3 : UCIP_SP_2019_53913_65333.jpg

Pumphouse on LS toe.

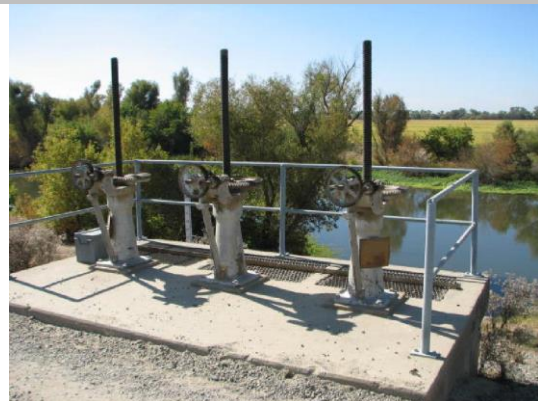
Photo 2 of 3 : UCIP_SP_2019_53913_65332.jpg

Slide gates on WS shoulder.

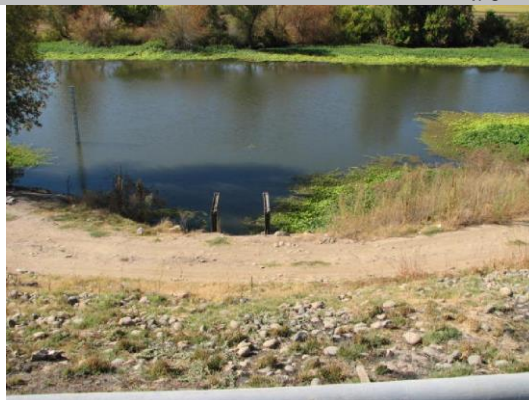
Photo 3 of 3 : UCIP_SP_2019_53913_65331.jpg

Flap gate at WS toe.

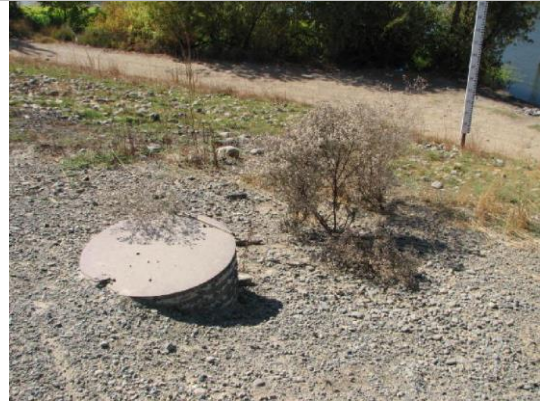
Photo 1 of 1 : UCIP_SP_2019_53914_65334.jpg

36-inch CMP riser on WS shoulder.

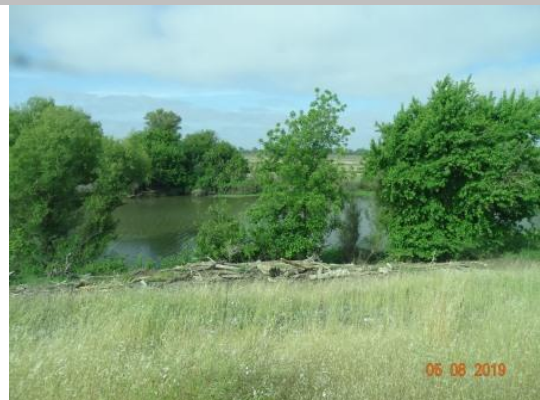
Photo 1 of 1 : SP_2019_ST0002_450_50_20190510_00085.jpg

View of tree trunks and limbs at the waterside toe. Spring 2019.

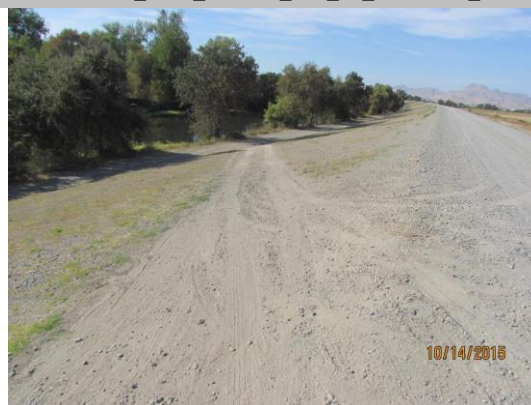
Photo 1 of 1 : SP_2019_ST0002_450_29_20190327_00006.jpg

View of the vehicle erosion along the waterside slope.

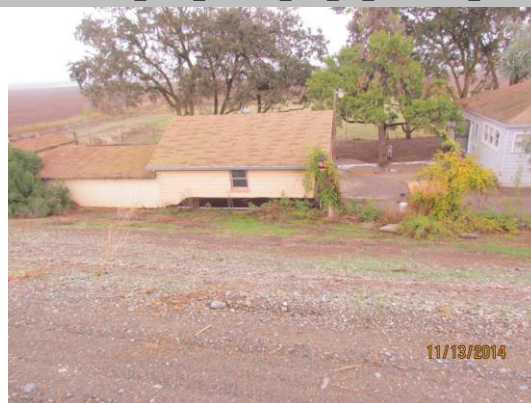
Photo 1 of 1 : SP_2019_ST0002_450_10_20190327_00001.jpg

View of the house next to the toe of the levee.
